COMPETITION SERIES

Project #: 2308 Both      Number of Sheets: 3  
Architect: J. L. Blatherwick, Ontario  
1959

Number of Storeys: 1, Bungalow--carport attached  
Single detached  
Number of Bedrooms: 3  
Fireplace? no,

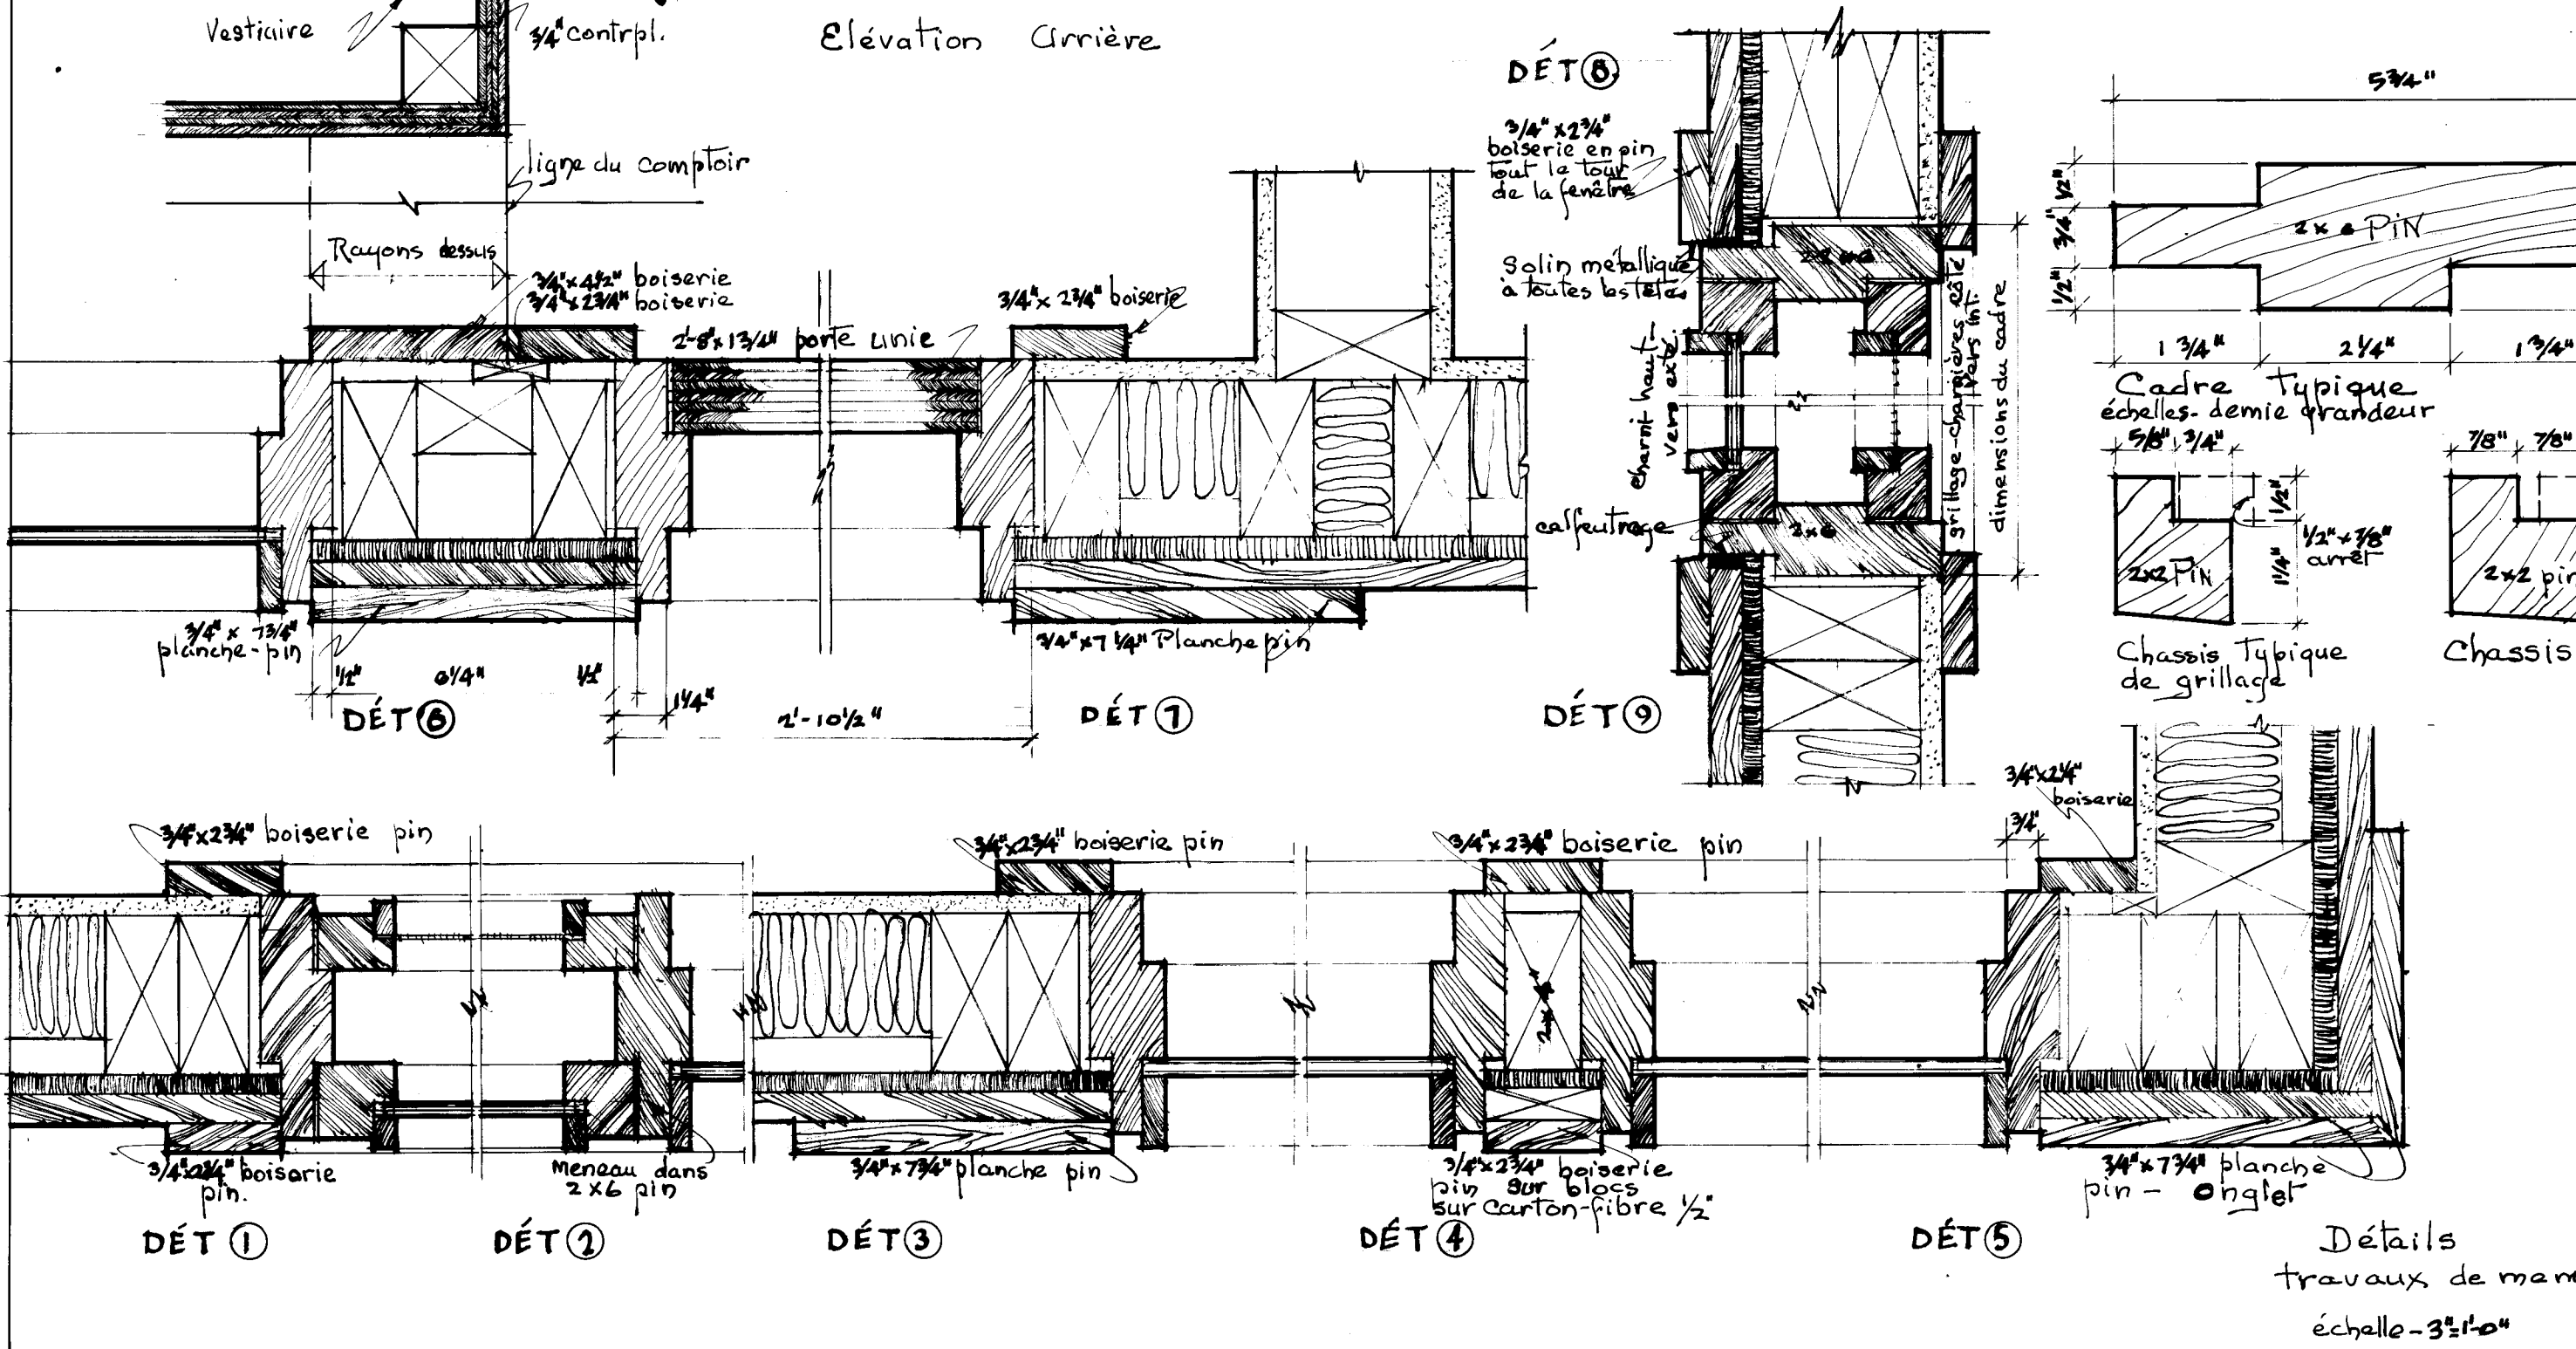
Détails travaux de menuiserie échelle 3/4" = 1'-0"

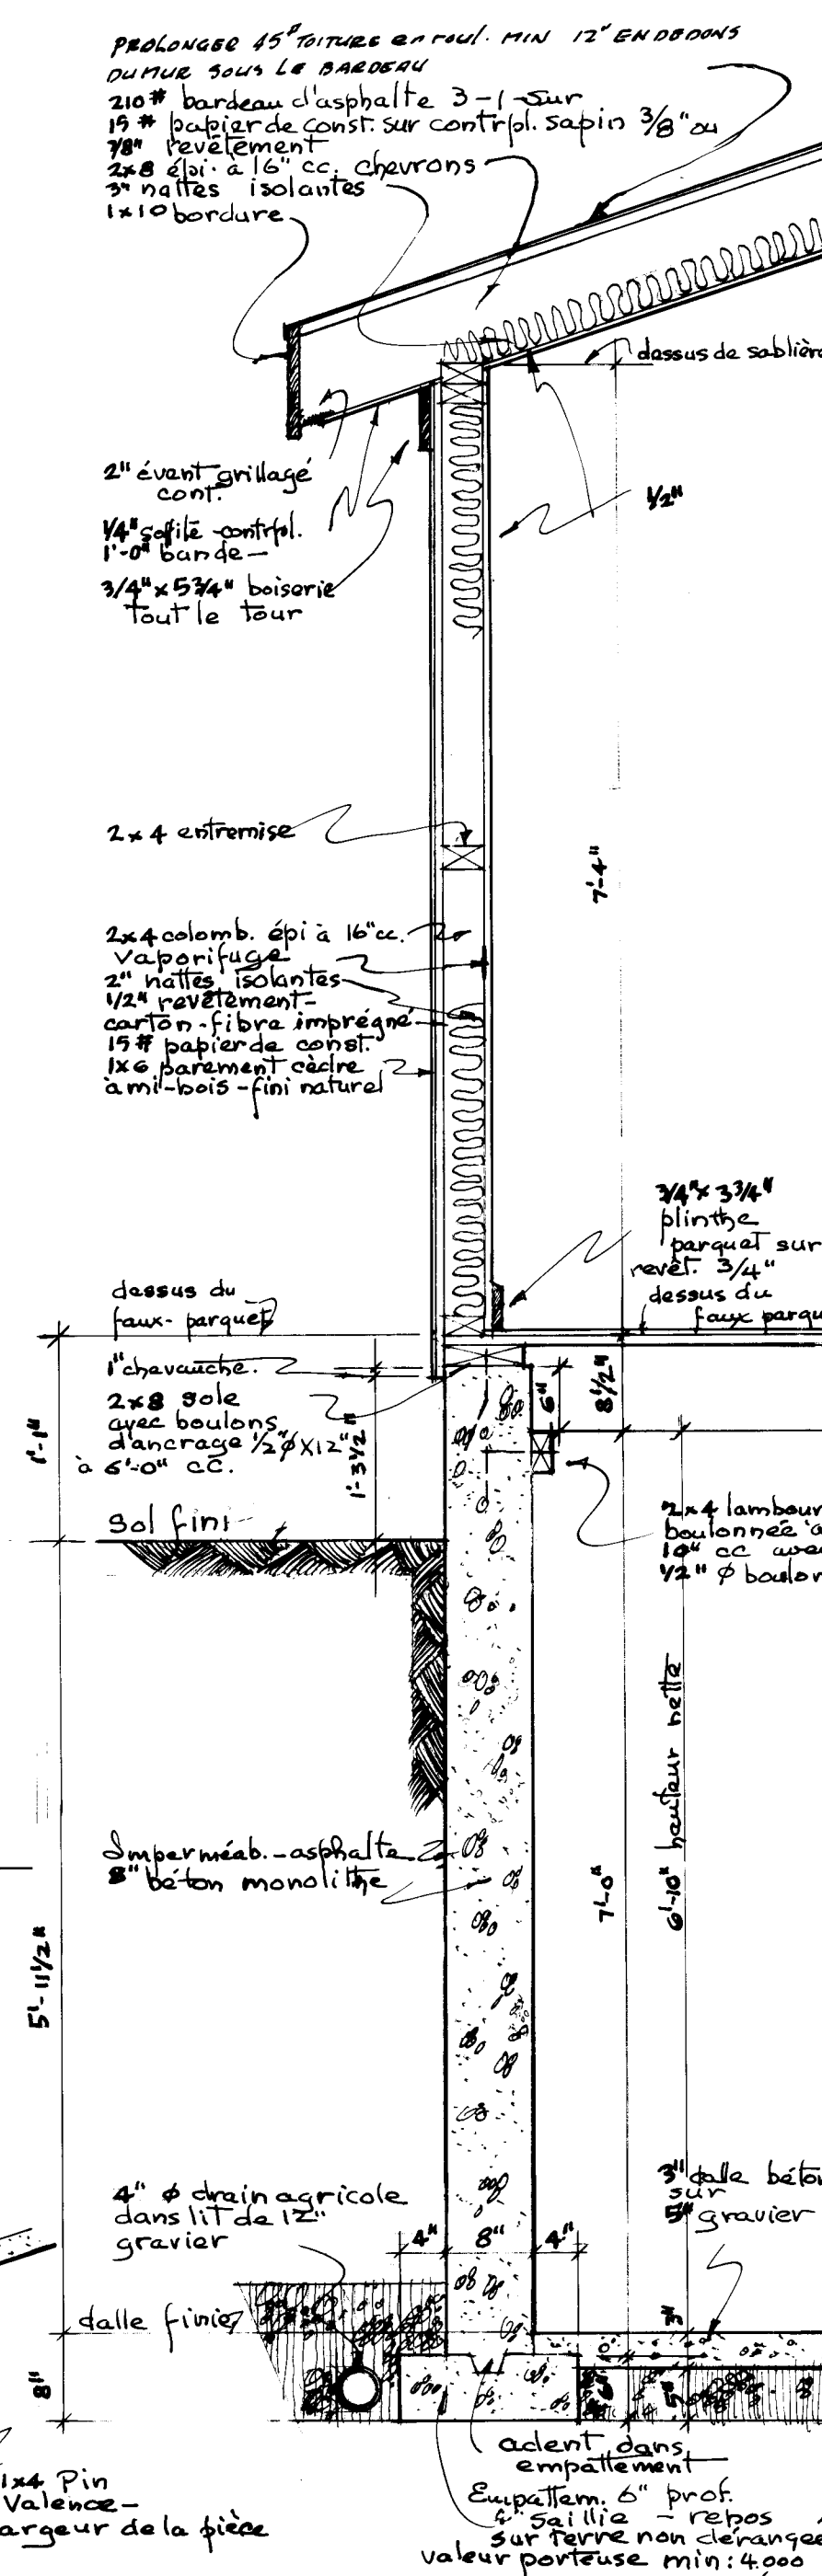
Section typique de mur échelle 3/4" = 1'-0"
